Marble Inlay

Conserving the Marble Inlay Work in the Marble Baths of the Karlsaue Palace in Kassel Using Modified Silicic Acid Esters

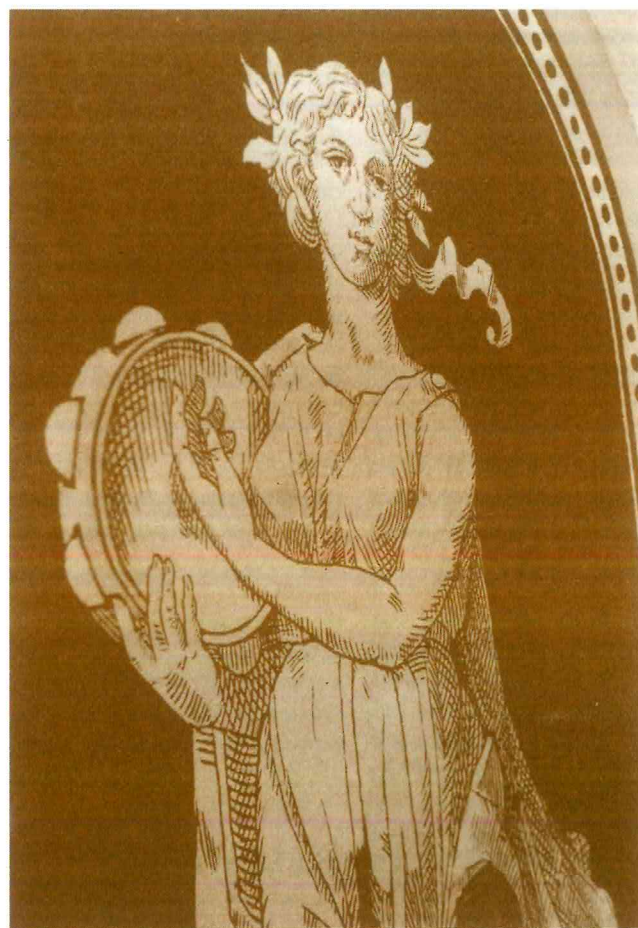
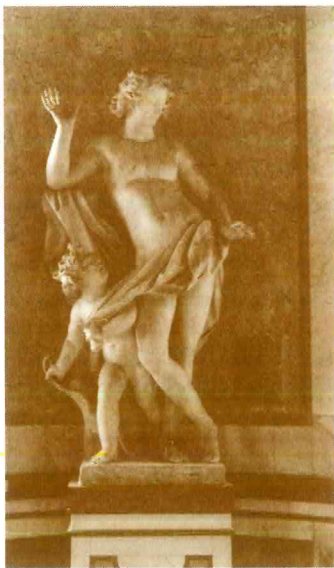
The rust spots can be seen on almost all of the original plates of white marble, and they significantly decrease the aesthetic value of the work. The rust is the result of the migration of the iron buckles' corrosion products (the buckles were used to secure the marble plates). The marble's crystalline structure has a high tendency to transport soluble iron salts from the substrate, a result of which is that the smallest

amount of these salts causes spotting on the white marble. Besides the aesthetic problems it creates, the corrosion of the buckles and the increase in corrosion product volume in the form of ferric hydroxide also causes the marble plates or their fragments to become detached.
